# **Dangerous shipwrecks of the Gdańsk Bay**

# **Debris of Stuttgart Hospital Ship in Gulf of Gdansk – Impact of Motor Vessel Wrecks on the State of the Marine Environment**

# Dangerous shipwrecks of the Gdańsk Bay

**T/S FRANKEN**

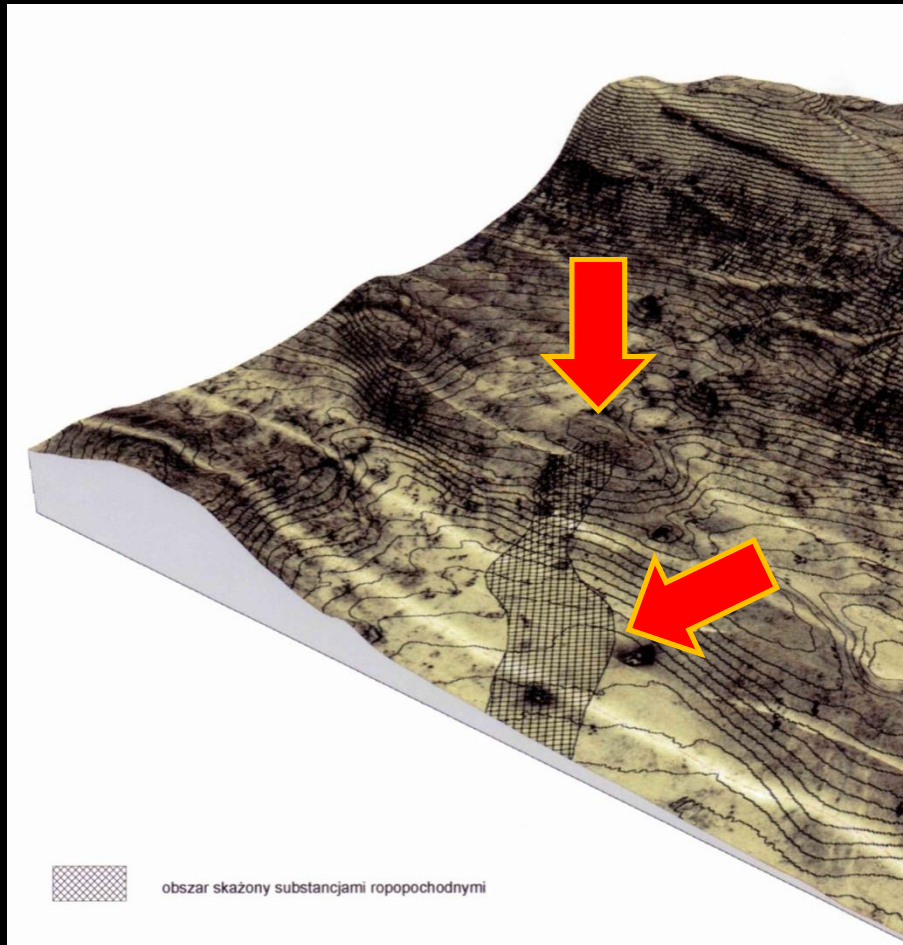
Run-off of heavy fuel in  
the direction of deeper  
water.

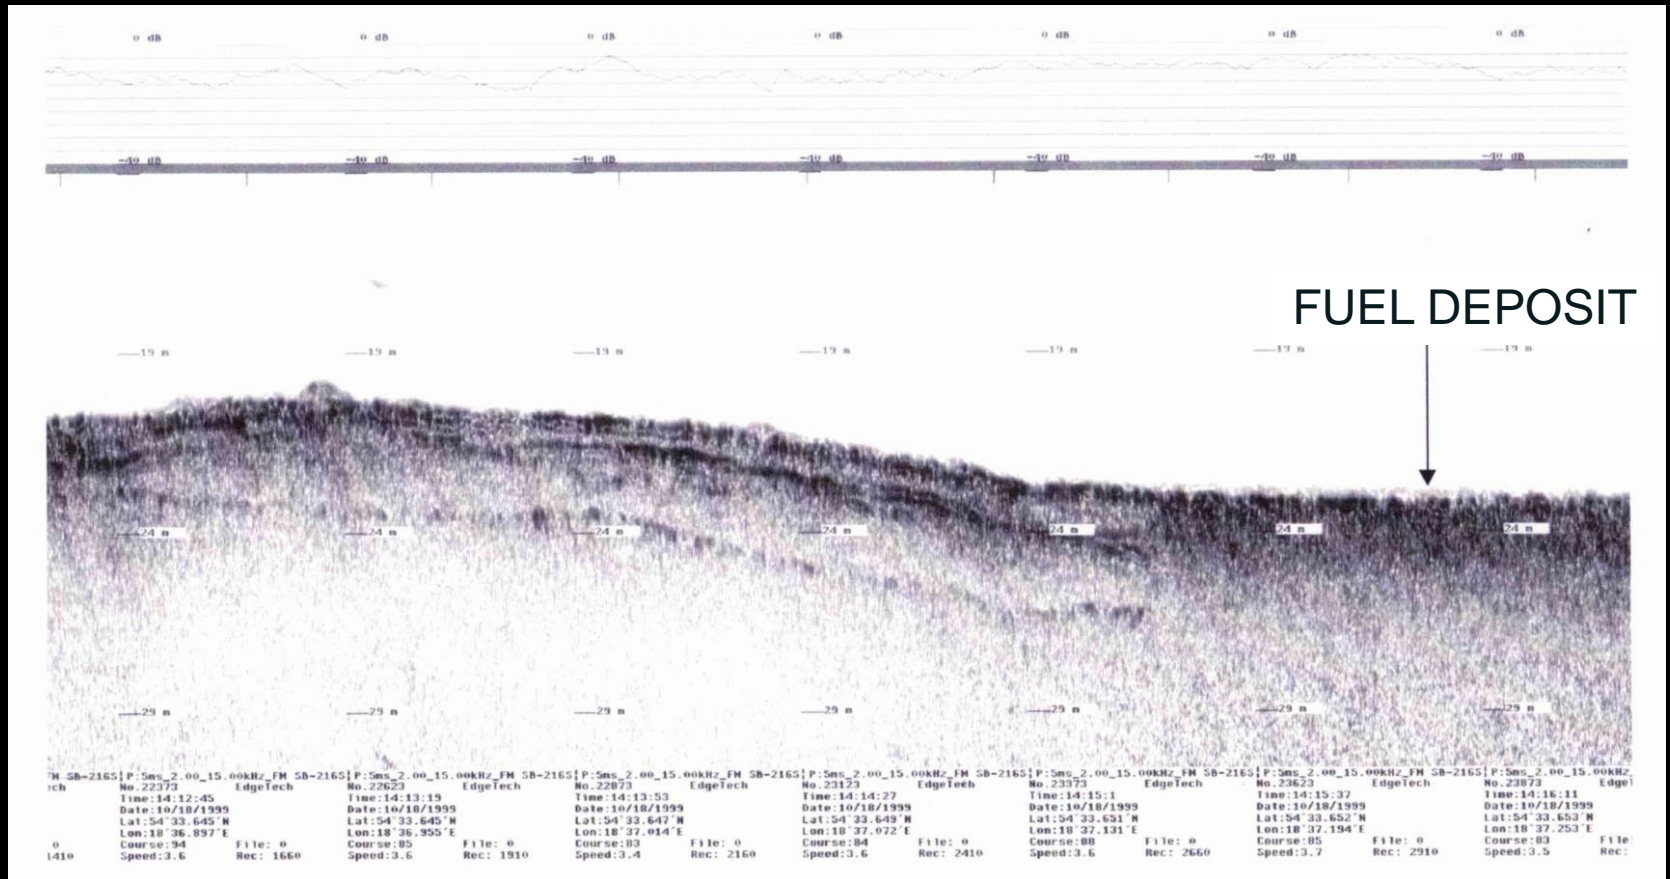
An example of a seismoacoustic profile with a layer of sand suffused with heavy fuel. (1999)

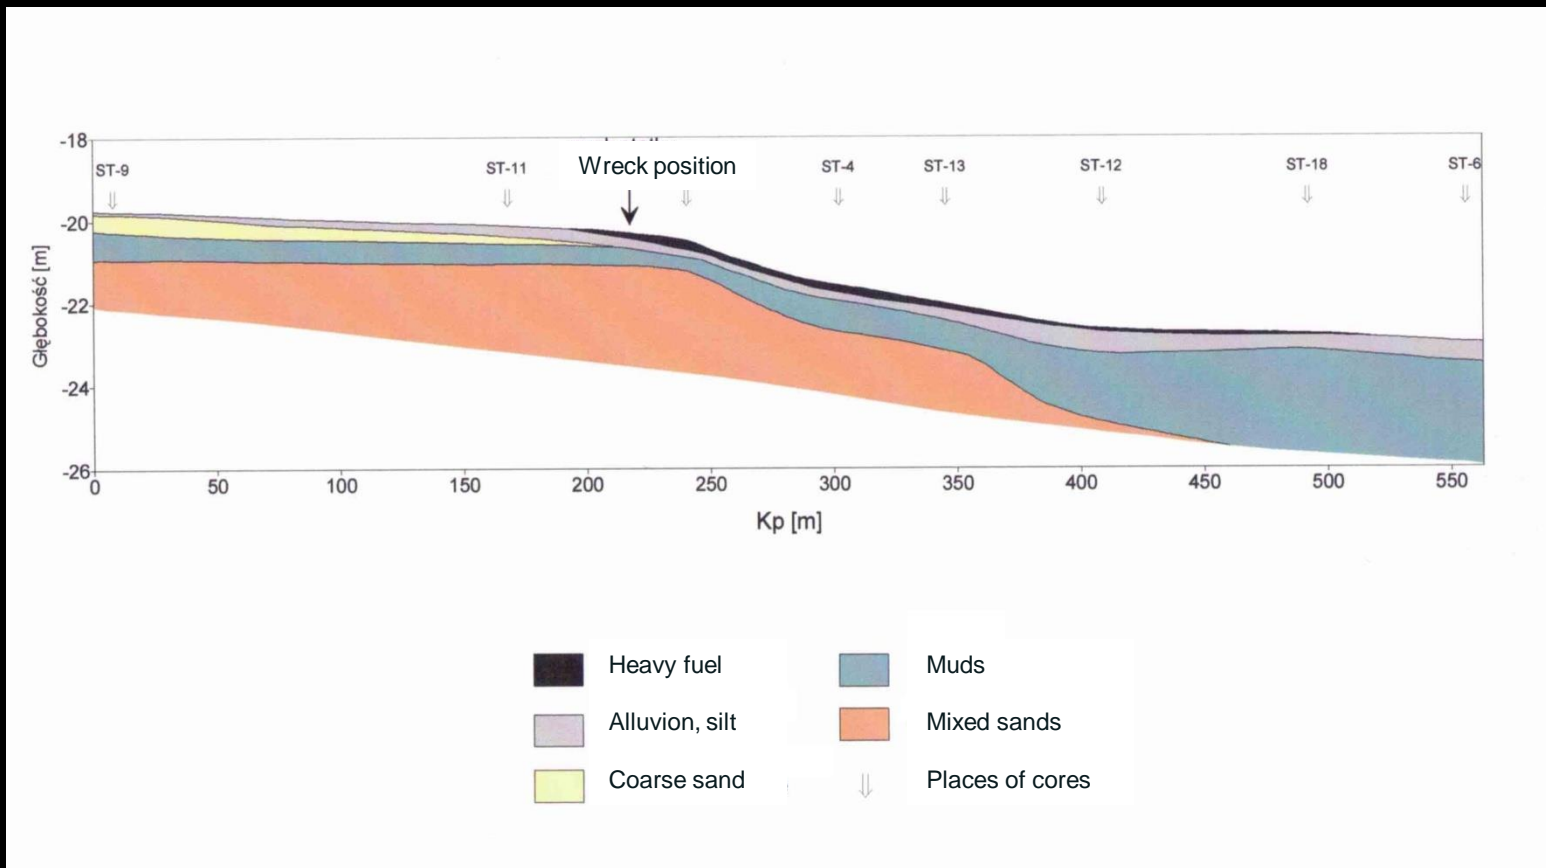
Geological situation and the distribution of contamination

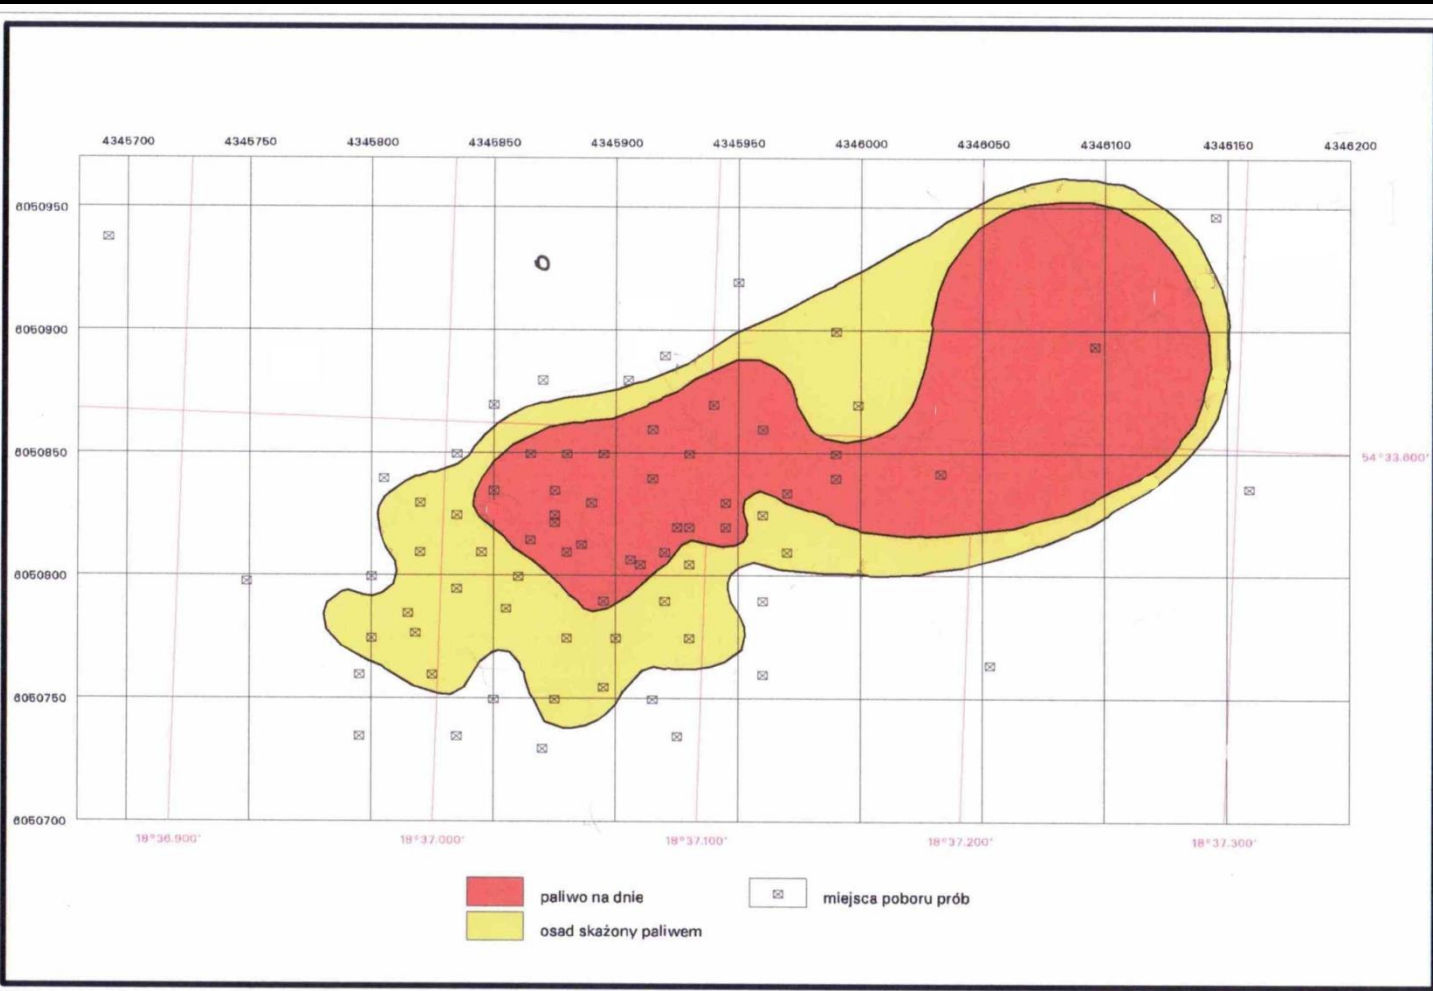
# Range of occurrence of contamination with the heavy fuel flowing out of the s/s „Stuttgart” wreck – state for 1999

Contaminated  
Area

**25 000 sq.m.**

Estimated volume  
of contaminated  
ground

**40 000 c.m.**

**(c.a. 70 000 ton)**

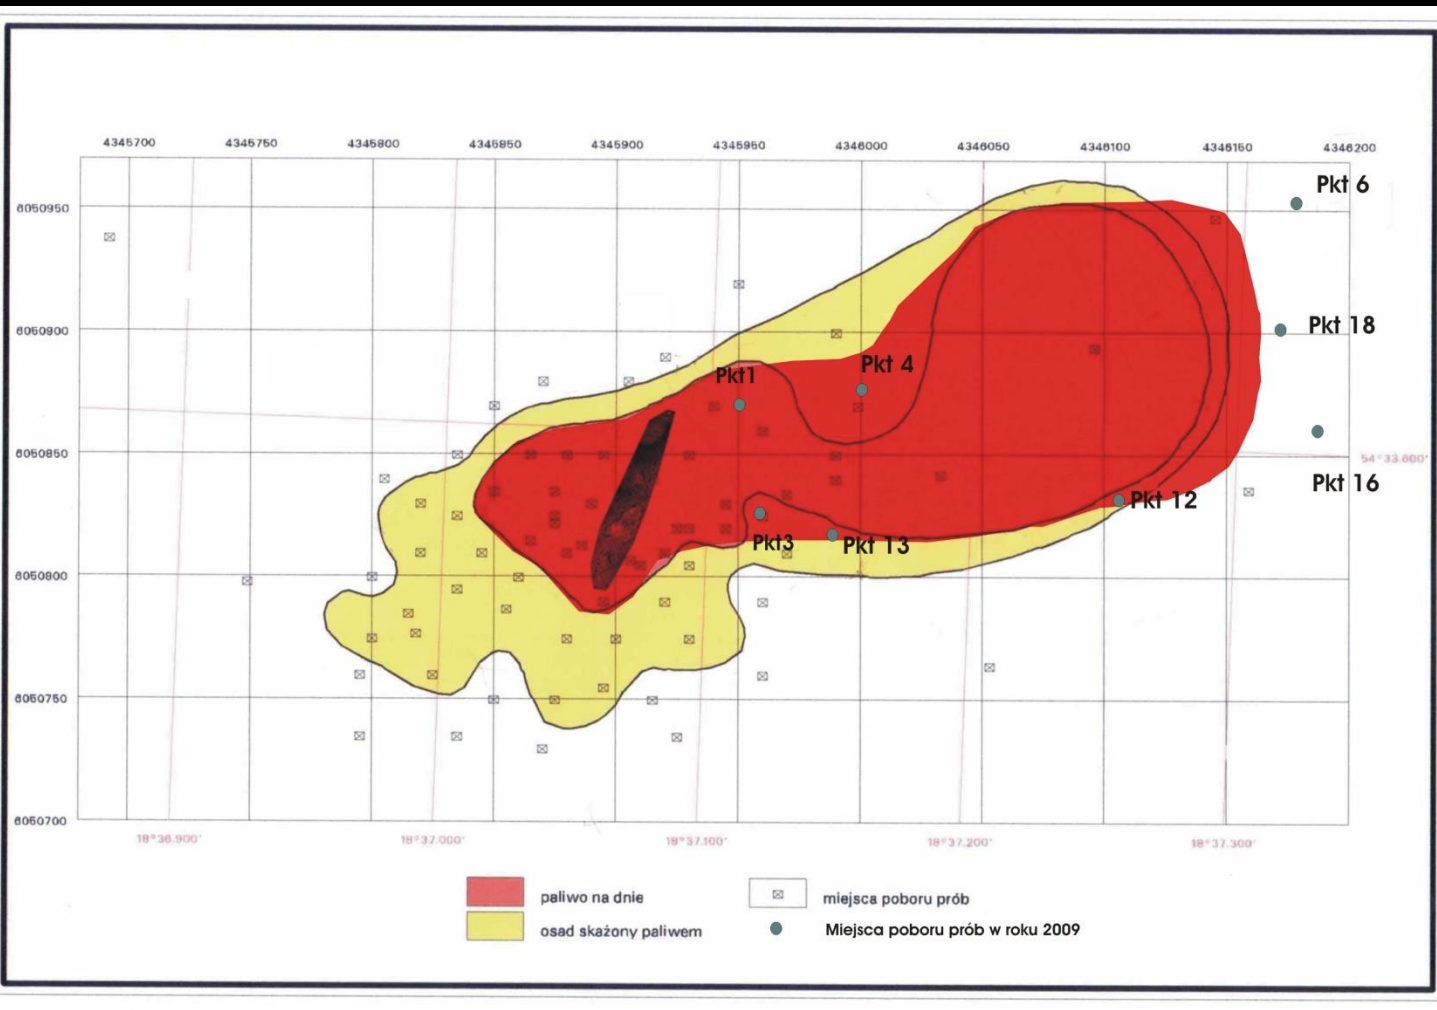
# Range of occurrence of contamination with the heavy fuel flowing out of the s/s „Stuttgart” wreck – state for 2009

Contaminated Area

**32 000 sq.m.**

Estimated volume of contaminated ground

**48 000 c.m.**

**(c.a.80 000 ton)**

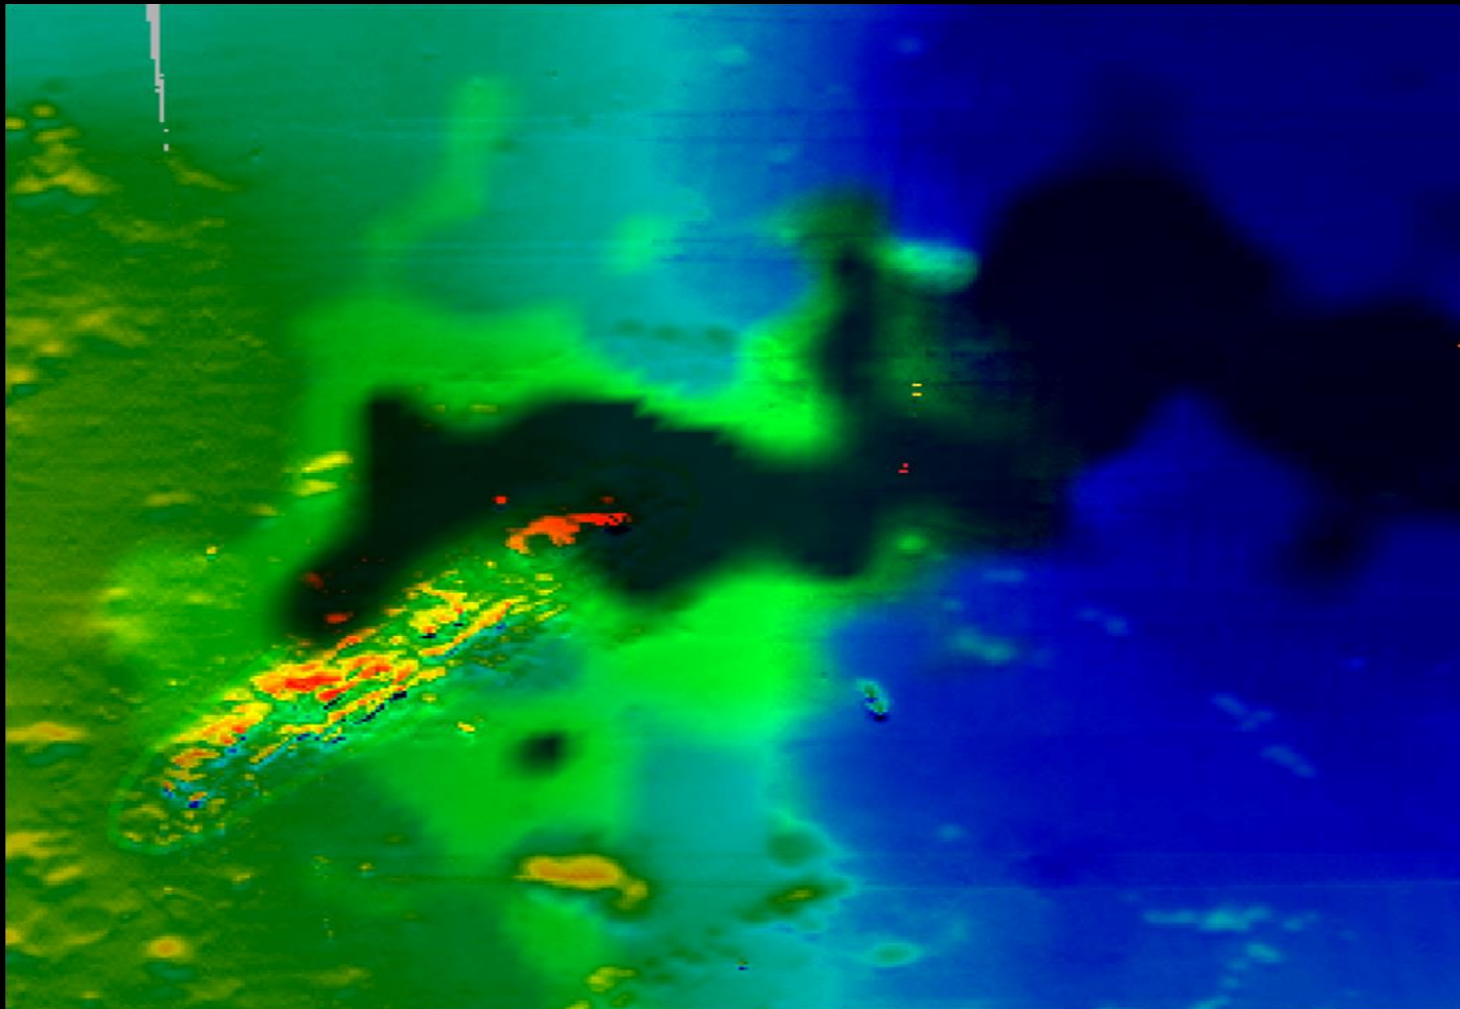
# Range of occurrence of contamination with the heavy fuel flowing out of the s/s „Stuttgart” wreck – state for 2012

Contaminated Area

**120 000 sq.m.**

Estimated volume of contaminated ground

**90 000 c.m.**

**(c.a.150 000 ton)**

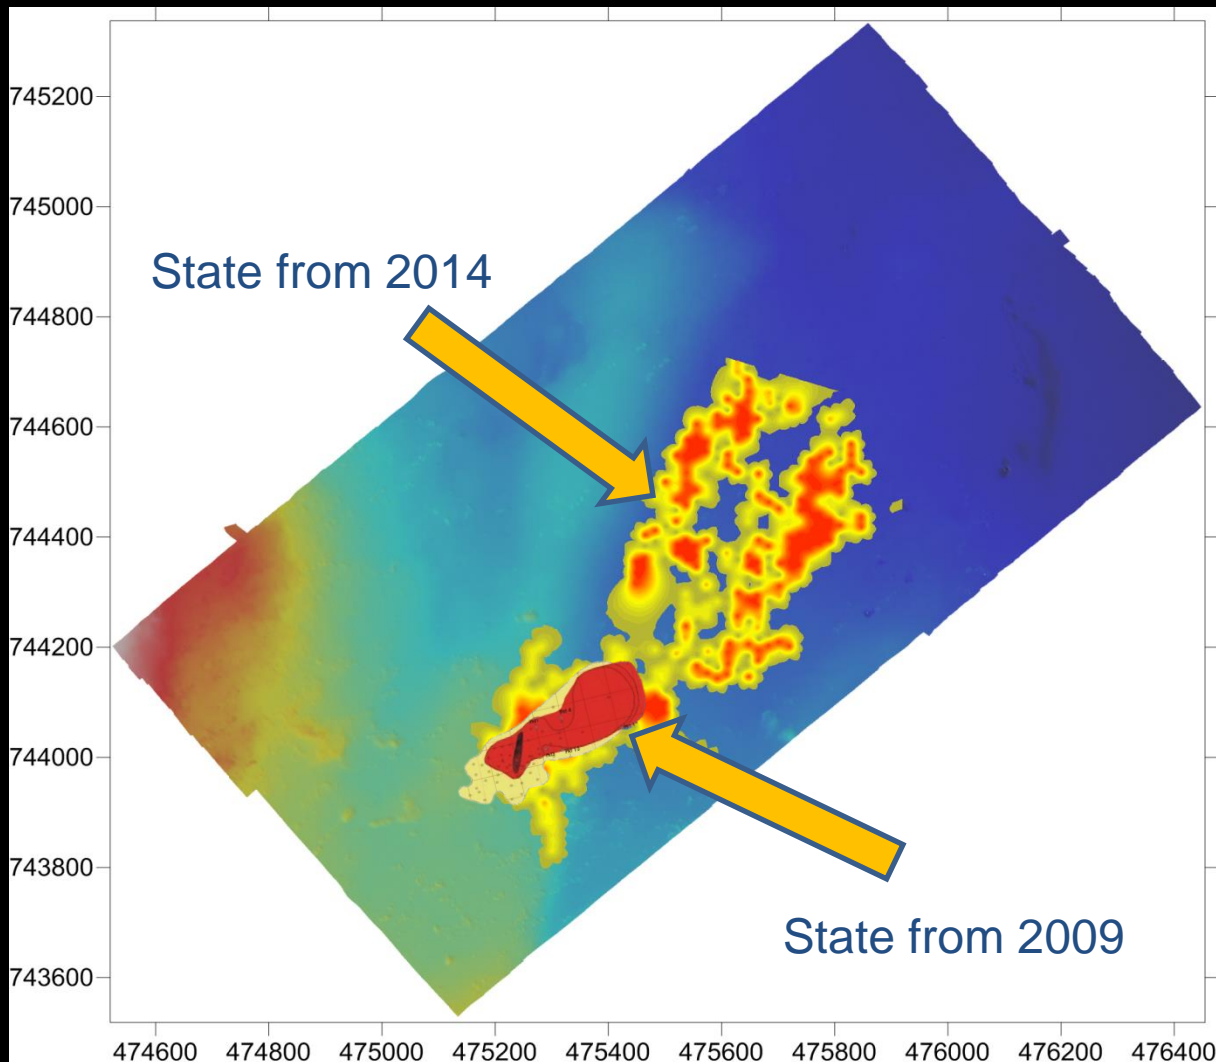
# Range of occurrence of contamination with the heavy fuel flowing out of the s/s „Stuttgart” wreck – state for 2014

Contaminated Area

**270 000 sq.m.**

Estimated volume of contaminated ground

**240 000 c.m.**

**(c.a. 350 000 ton)**

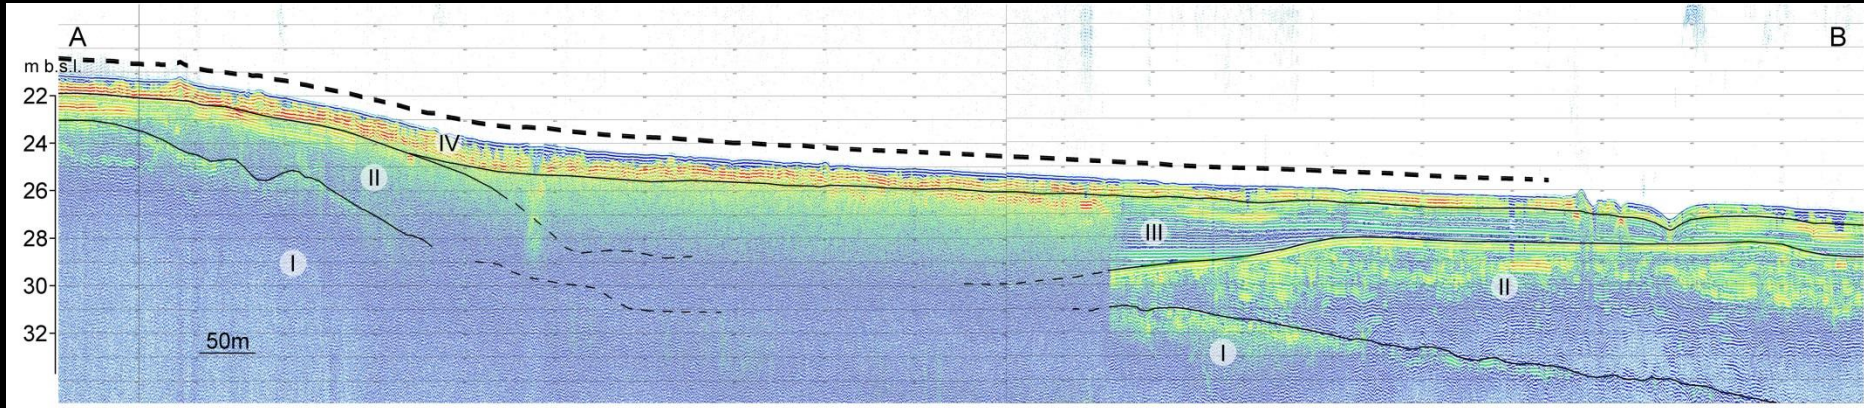
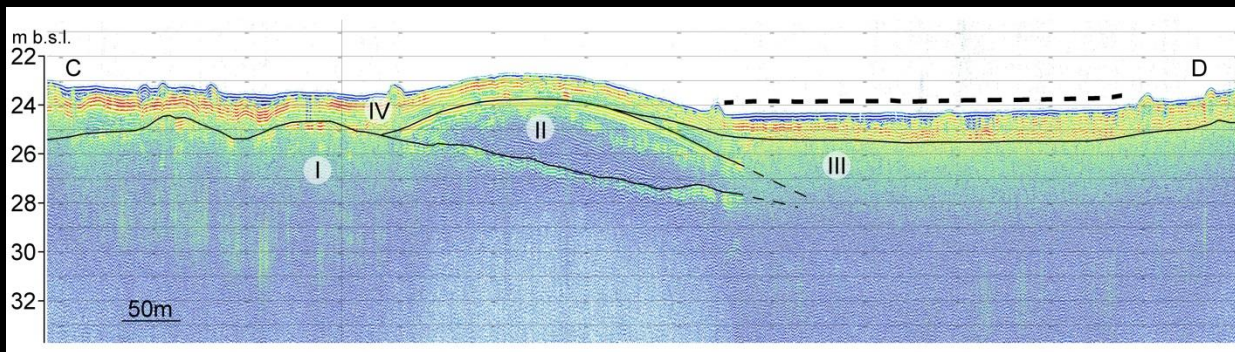
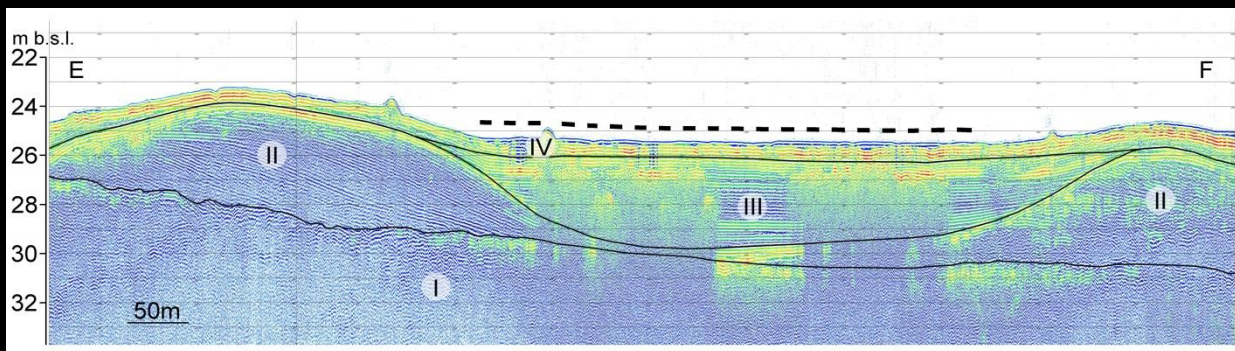
An example of a seismoacoustic profiles with a layer of sand suffused with heavy fuel.

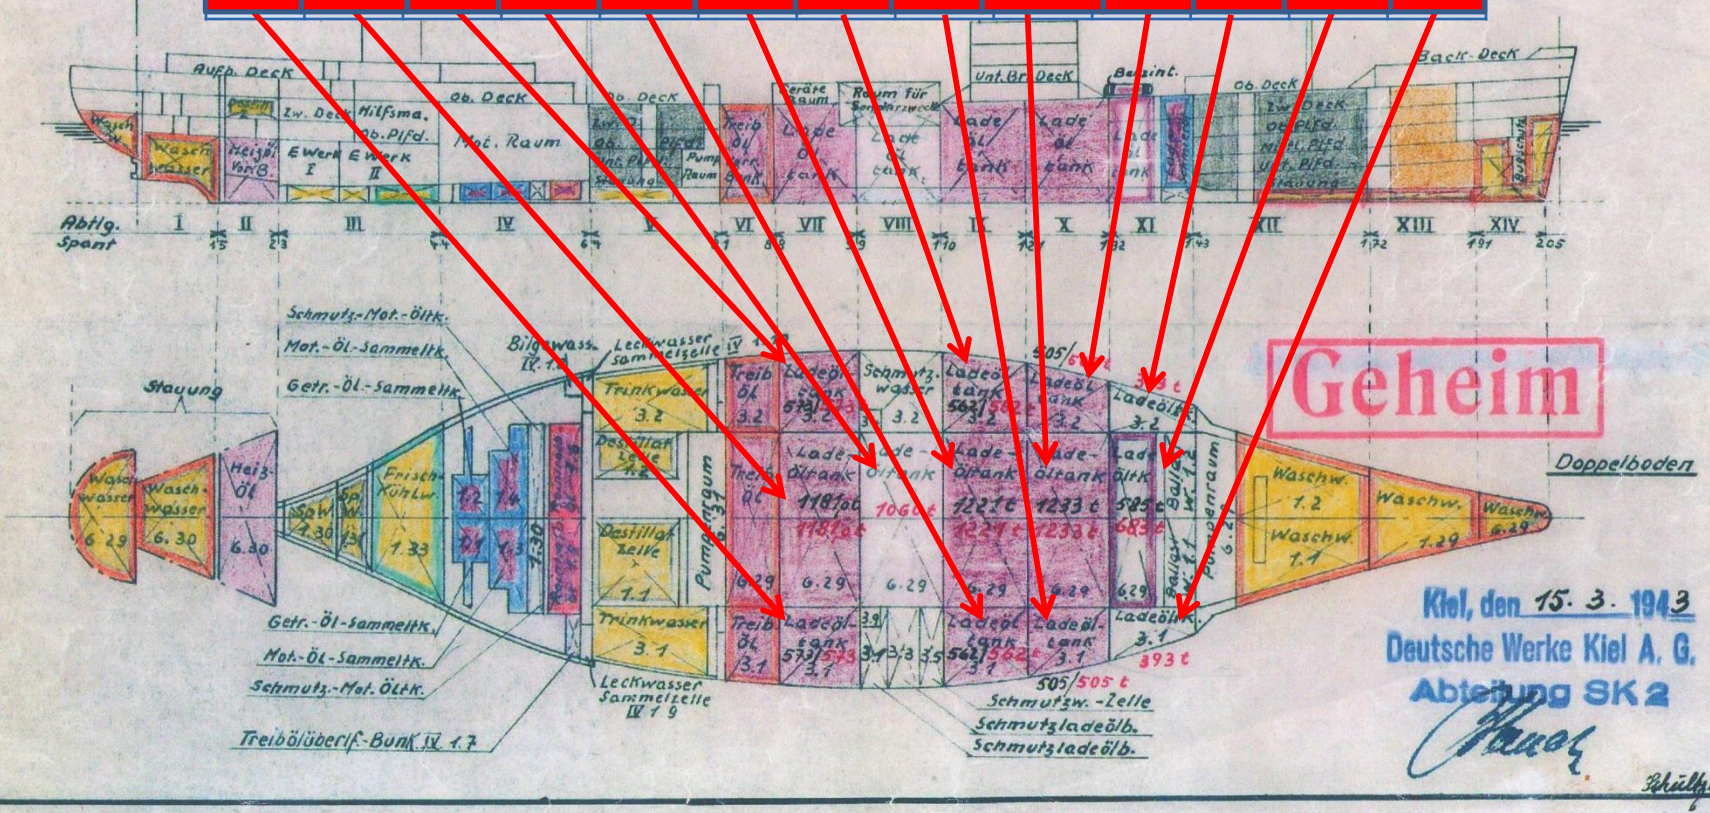
T/S FRANKEN - could have had 9500 tons of fuel in its tanks

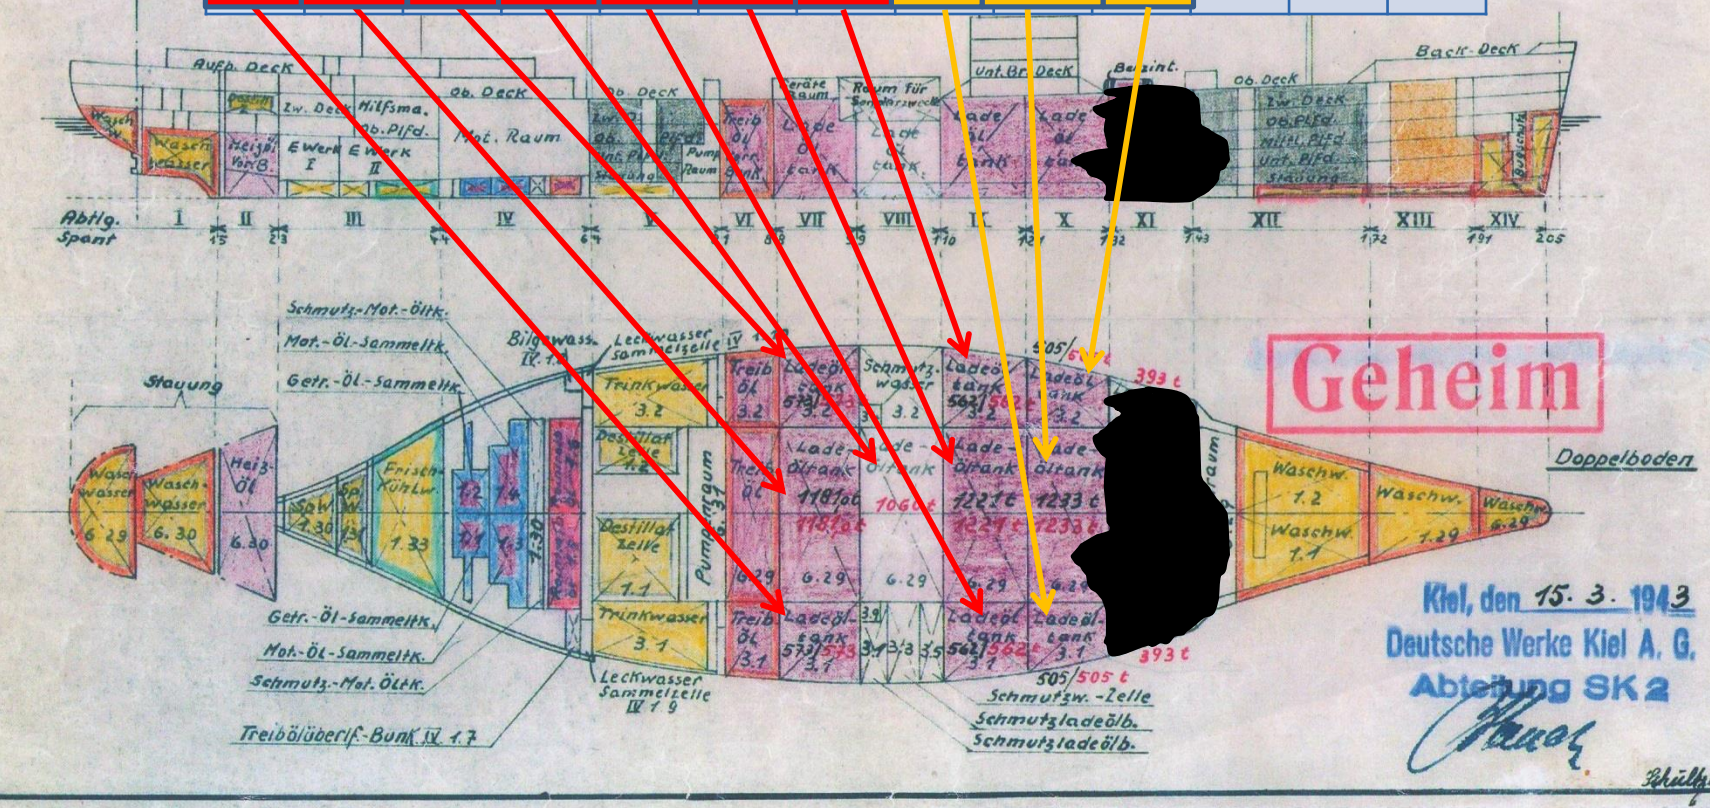
T/S FRANKEN - after losing the bow it was still able to hold a few thousand tons of fuel in its tanks

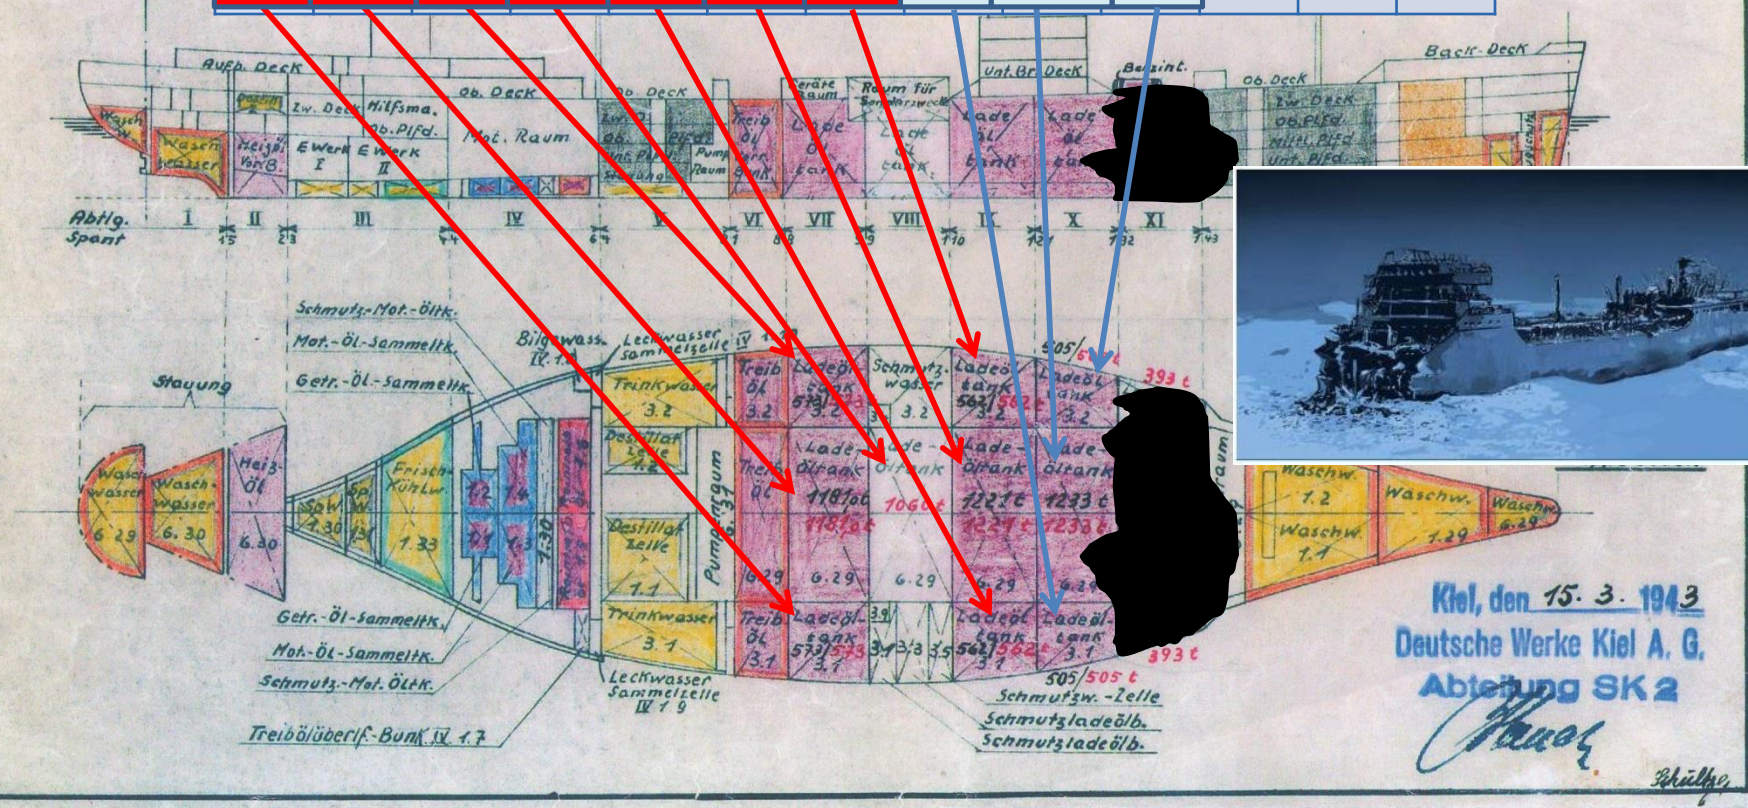
T/S FRANKEN - could still have about **6 thousand tons of fuel in its tanks**

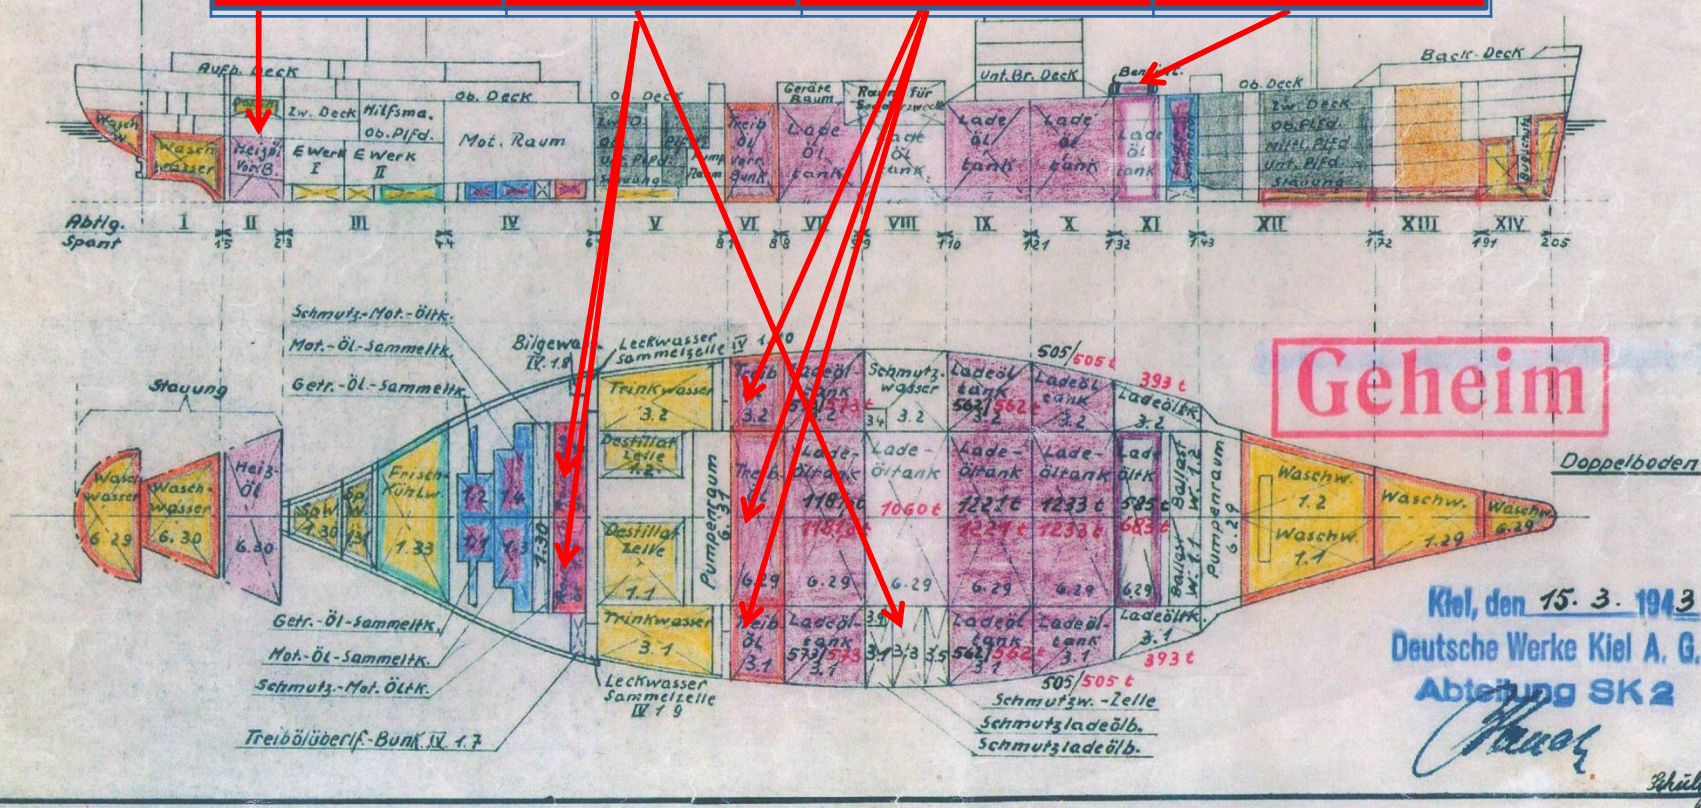
T/S FRANKEN - could have had about a thousand tons of other oil products in its tanks

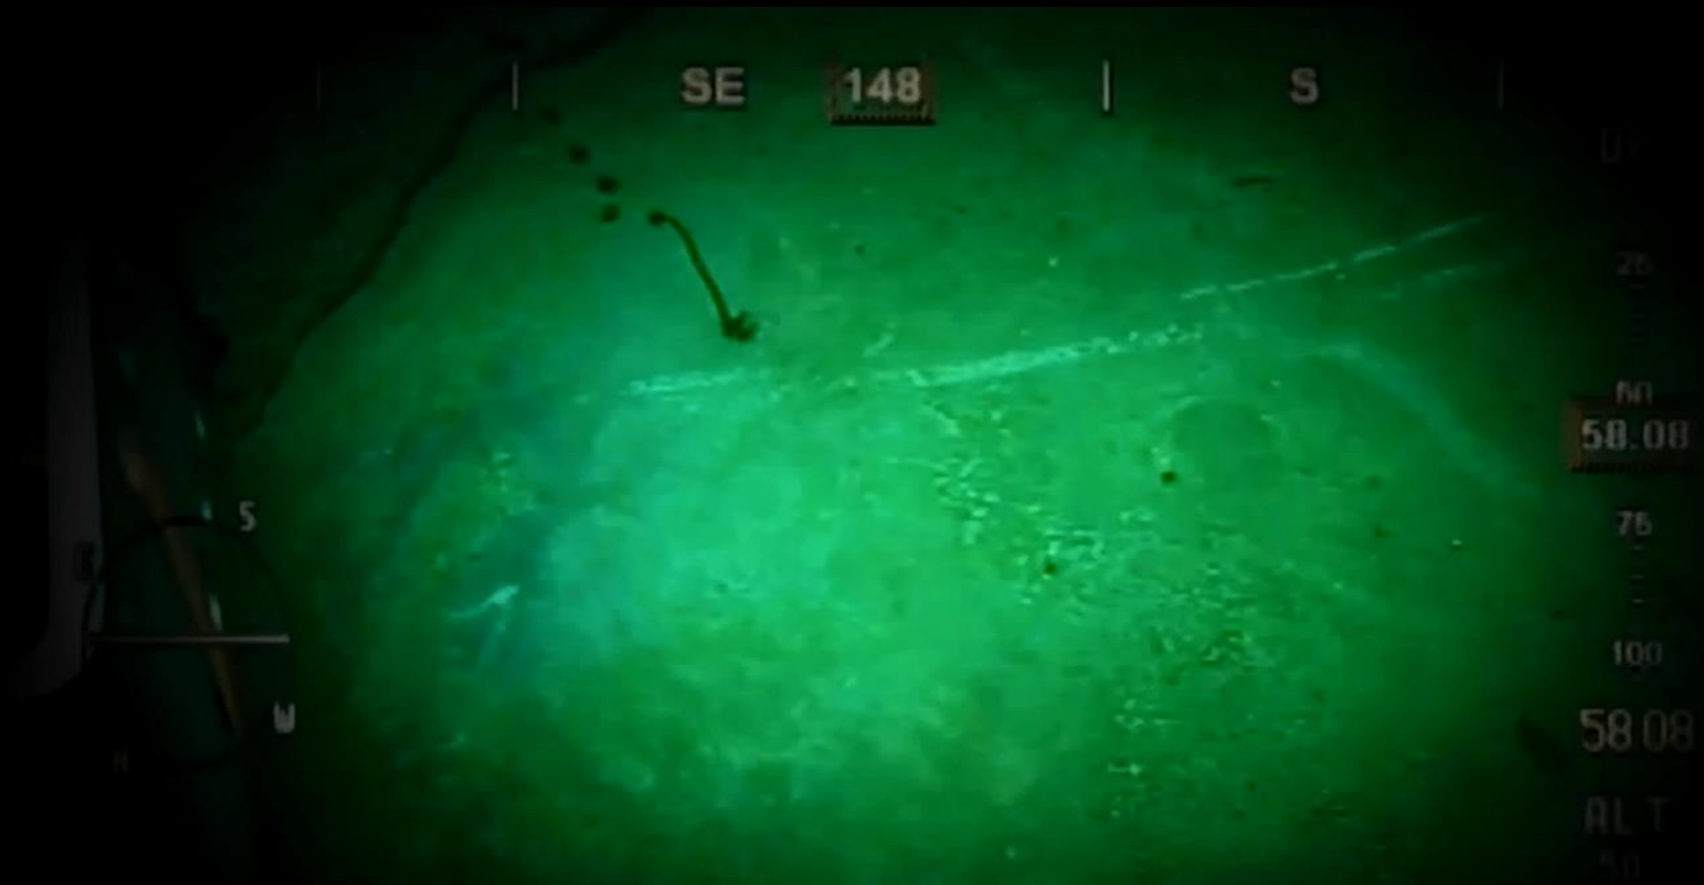
spills we were looking for

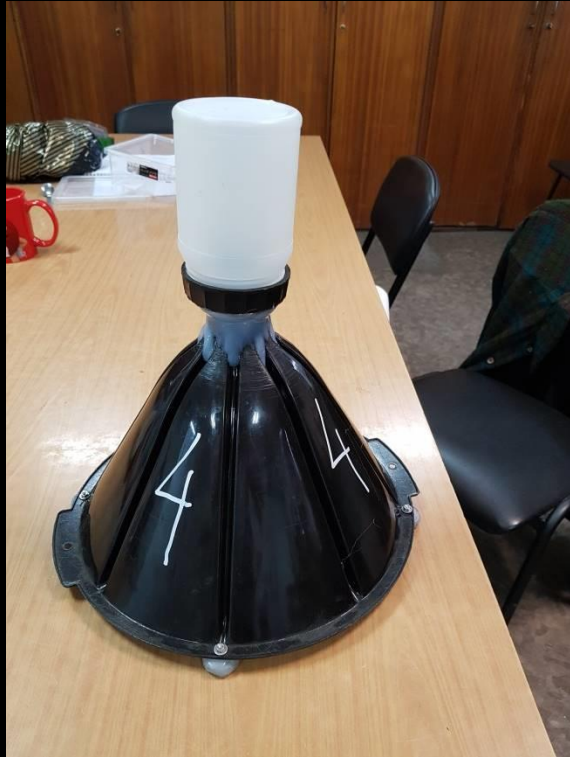
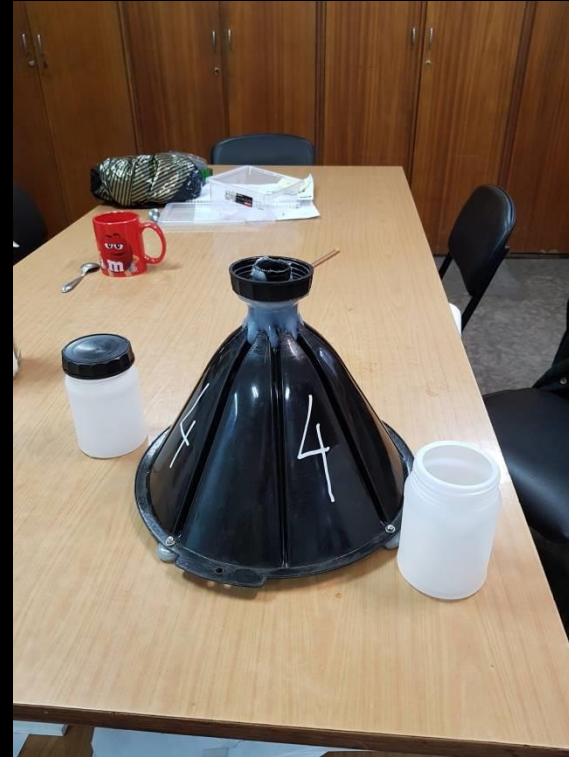
traps for leaking fuel

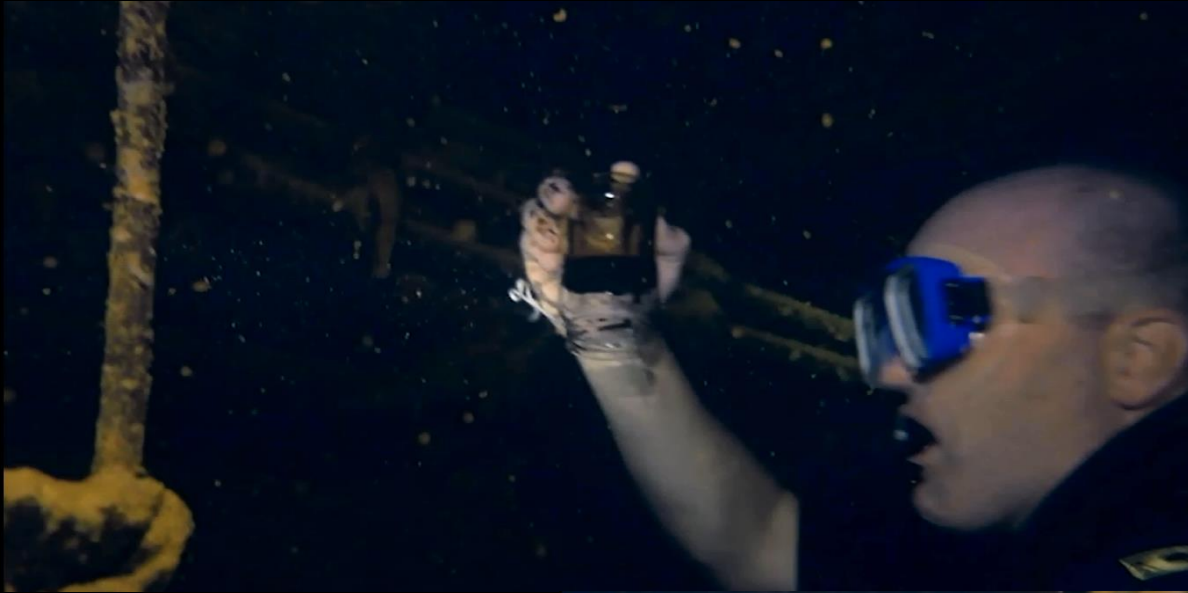
we are looking for fuel that leaked and is under the ceiling

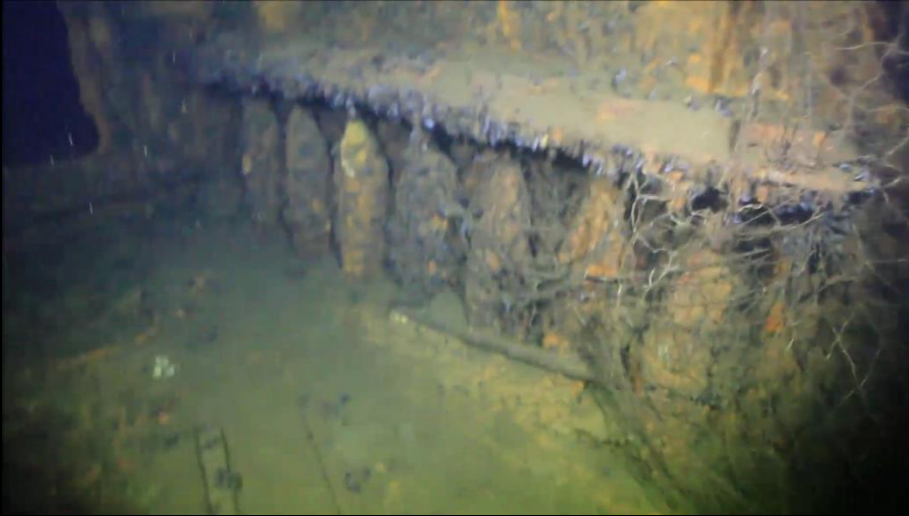
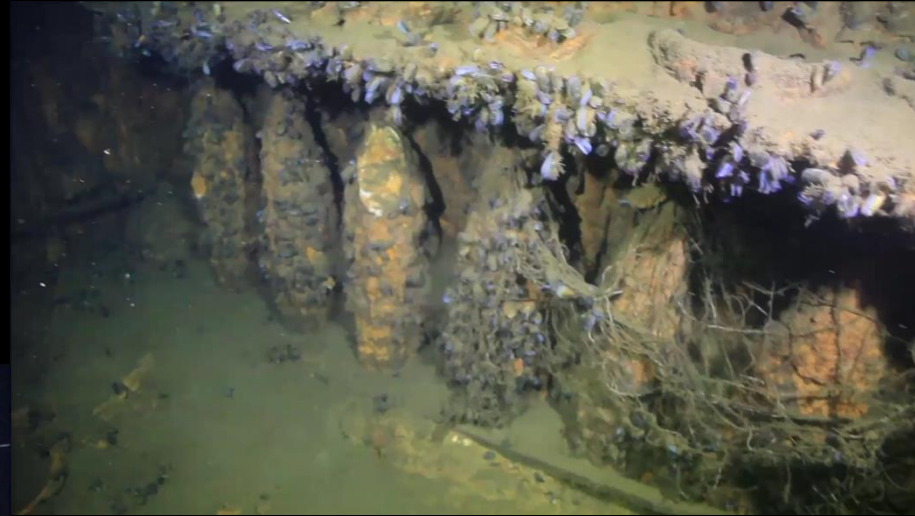
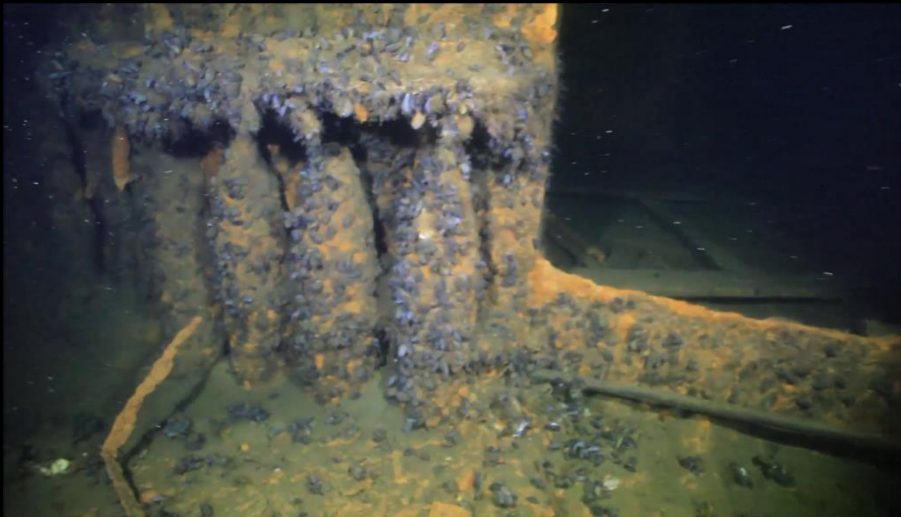
150 mm ammunition close to aft anti-aircraft gun
