Environmentally hazardous shipwrecks

Swedish national programme

- work procedure, examples and lessons learnt

Swedish Agency
for Marine and
Water Management

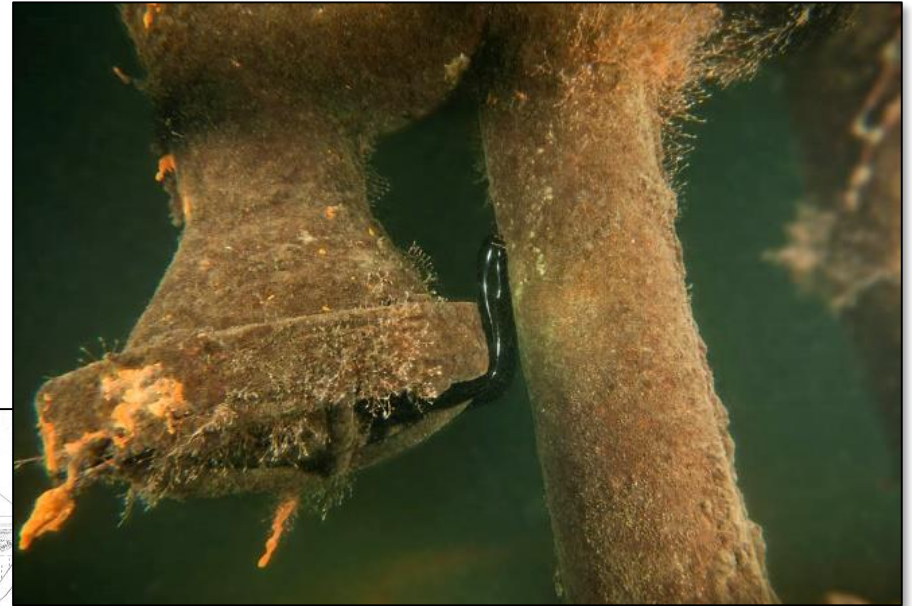
Oil from gooseneck piping, shipwreck Harburg. Swedish Coast Guard

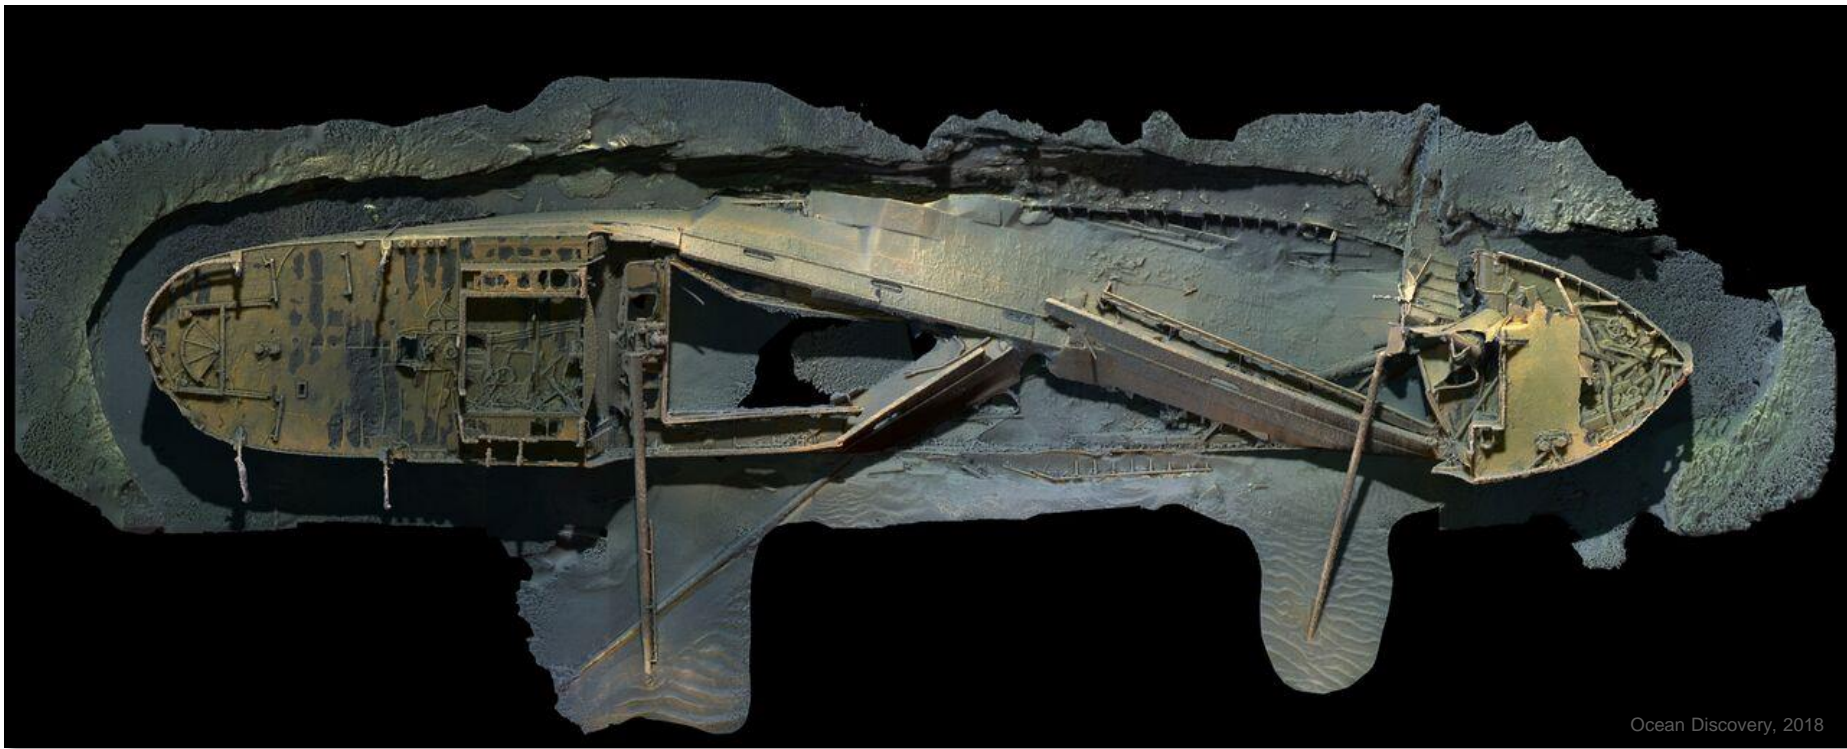
Pictures from 3D-model of the wreck, photogrammetry

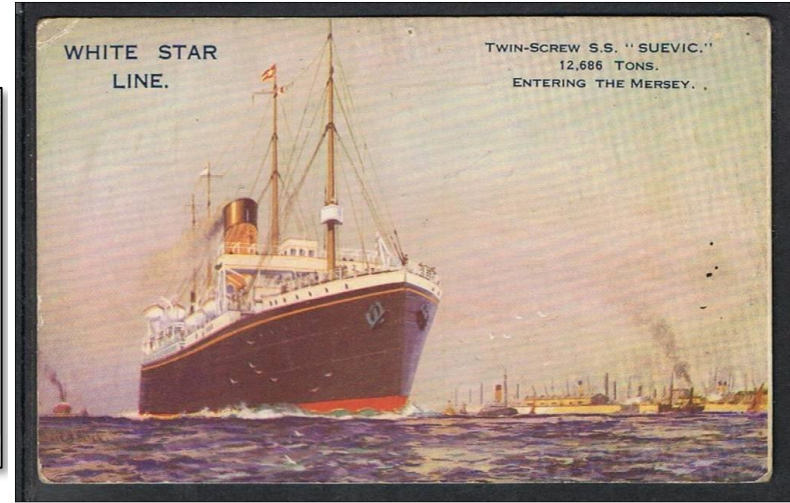
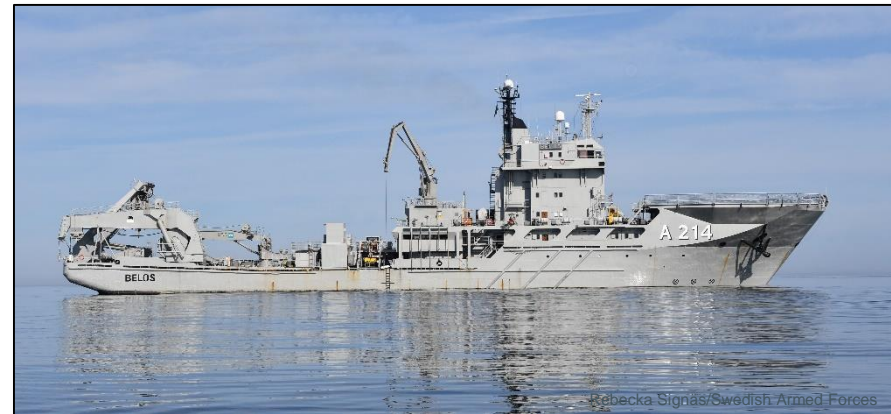
Shipwreck Skytteren

- 172m, 12000 gt, 1942, ~500 t oil
- ROV/Diving assignment
- Swedish navy - HMS Belos
 - Belos divers – wet bell
 - Clearance divers
- General investigation of the wreck, condition, deterioration
- Places of oil leakage
- Hull thickness measurements
- Other - holes, pit corrosion, fishing gear?

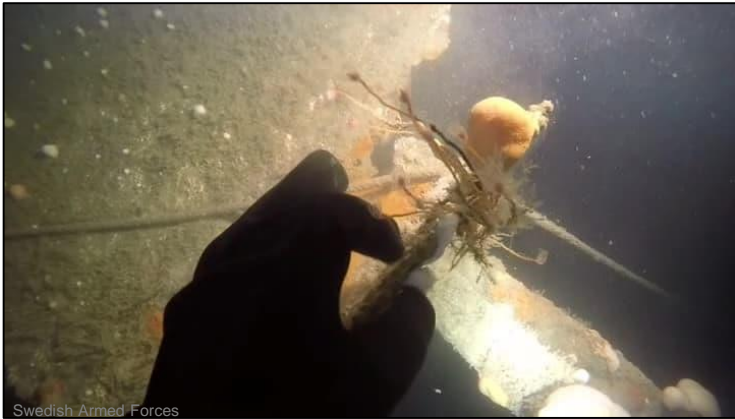
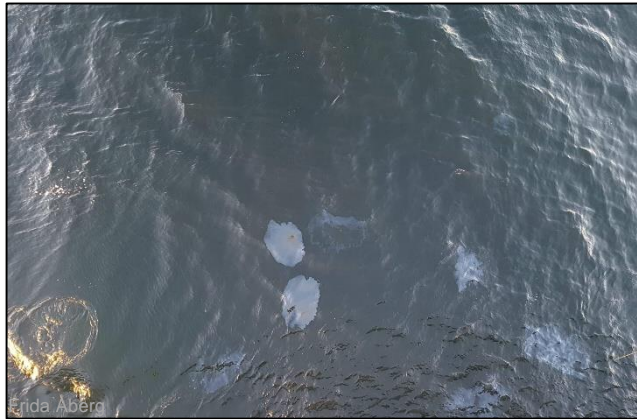
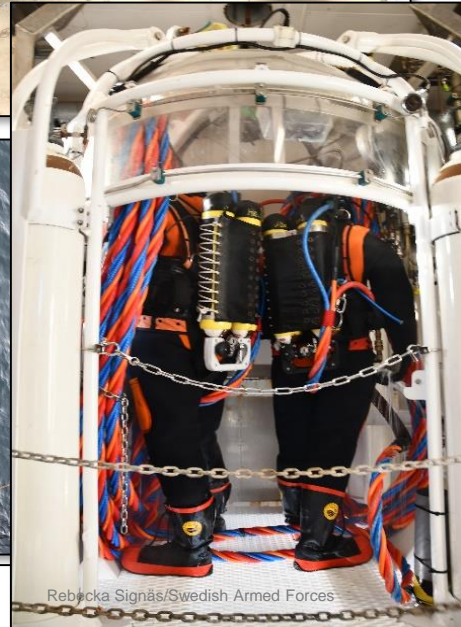
- Strong surface (1-3 knots) and sea-floor (1-1,5 knots) current
- Investigations of the keel area, whole length of wreck

- Hull thickness - 4-11 mm
- Nails more corroded than hull
- Oil leakage visible on surface

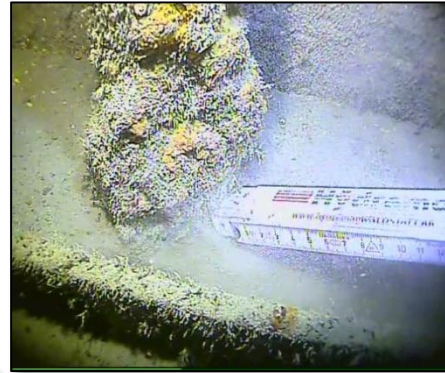
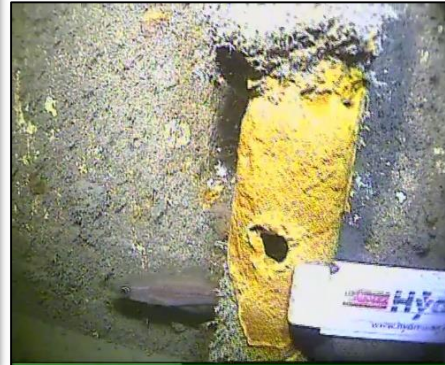
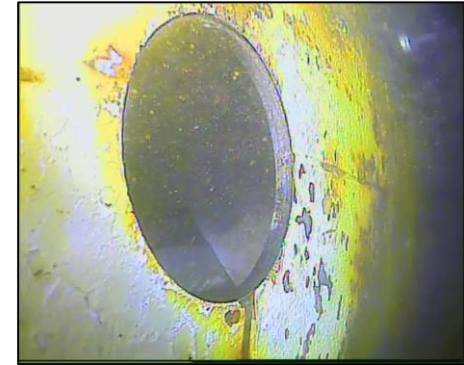
Shipwreck Thetis

- Oil removal – 2017
 - Test case
 - Close to shore, ROV and diving operation
 - Time of wreckage ~22 m³ diesel
 - Recovery ~1m³
 - Filling pipes corroded

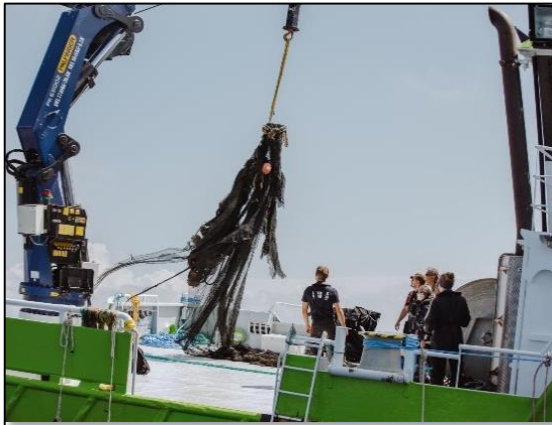
Shipwreck Thetis

- Oil removal – 2017
- Ghost net – 2018
 - Purse seine (400x100m)
 - Recovery 12- 15 tons

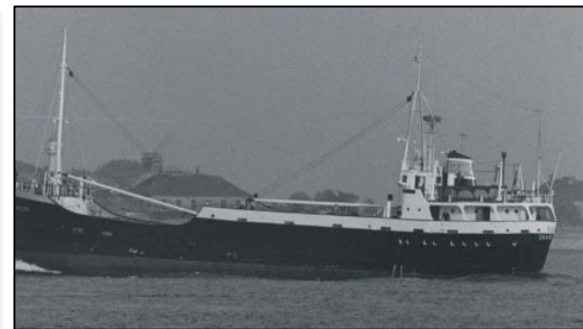
Sandön & Hoheneichen

- Geographically close – economically advantageous
- Easy objects – possibility within 2018
- M/S Sandön
 - Coaster, 499 gt
 - Fire in machine room, 1975
 - Bunker 40t
- M/S Hoheneichen
 - Coaster, 499 gt
 - Storm, 1959
 - Bunker 18t
- No reports of oil leakage

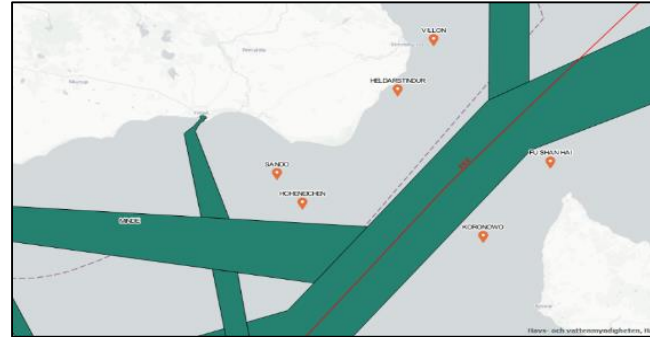
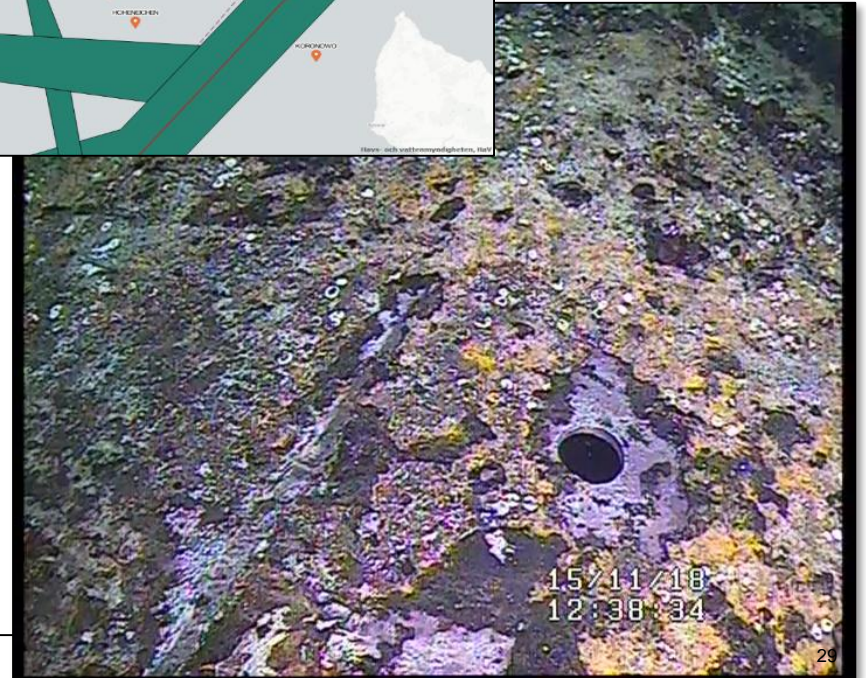
Sandön & Hoheneichen

Prerequisites:

- Depth: 31-18 m
 - Diving operation
- Easy access: keel-side up
- No owner
- No human remains in the wreck
- Not in a shipping lane
- Limited commercial fishing activity in the area

Result : no oil!
