# **Dangerous shipwrecks of the Gdańsk Bay**

# **Debris of Stuttgart Hospital Ship in Gulf of Gdansk – Impact of Motor Vessel Wrecks on the State of the Marine Environment**

# Dangerous shipwrecks of the Gdańsk Bay

**T/S FRANKEN**

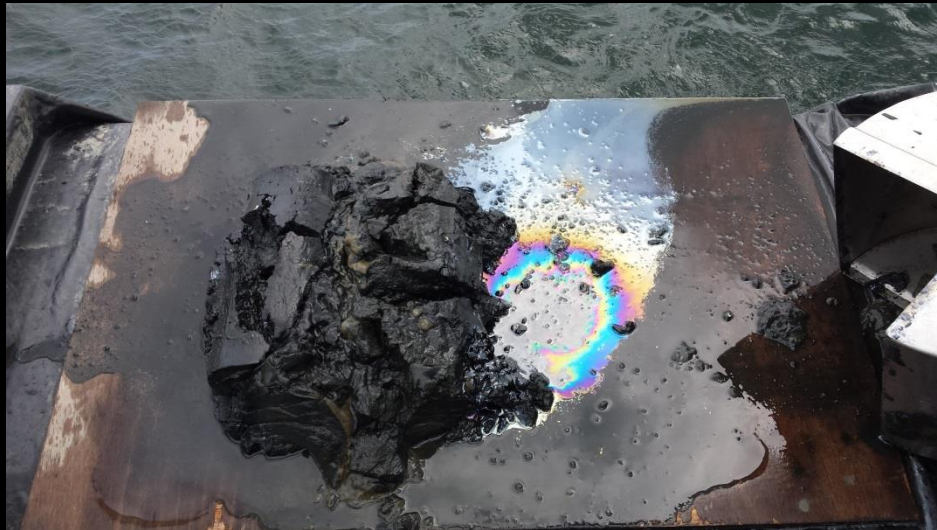
One from 650 samples taken by Van Veen grab

– thin film of oil on deck

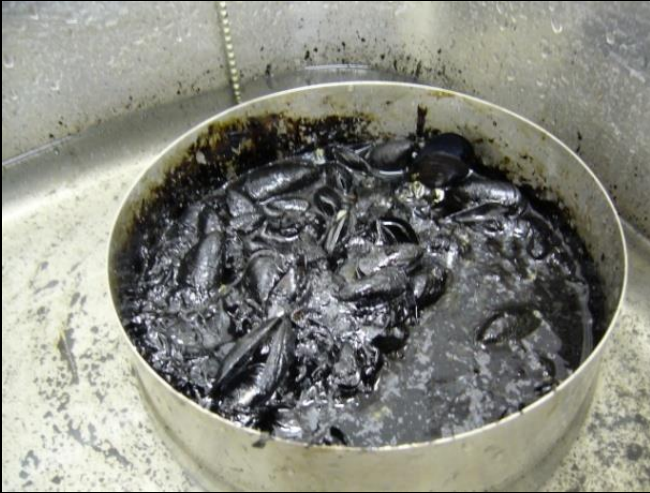
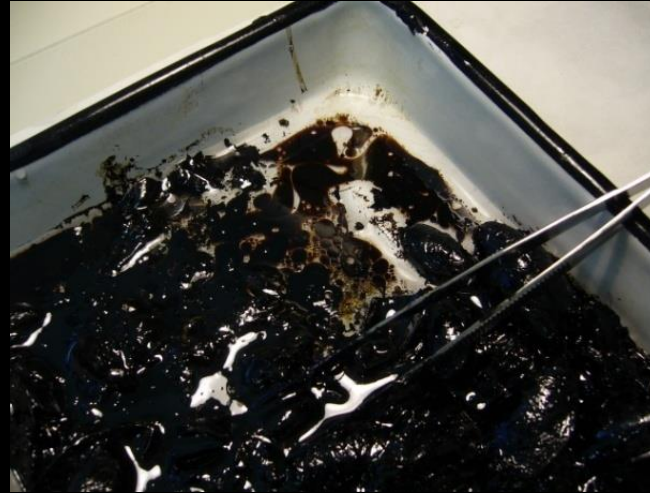
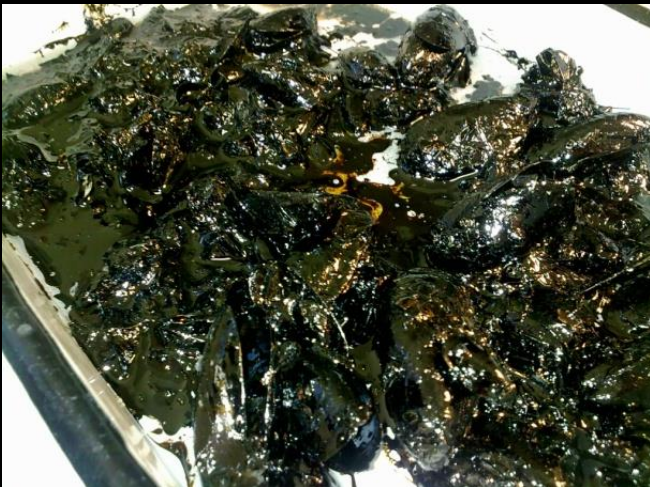
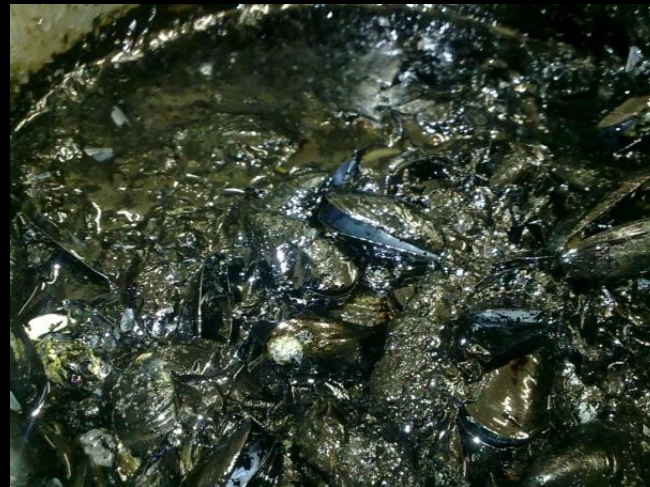
Macrozoobenthos samples collected in the area of the Stuttgart wreck in November 2009.

- **Surveys – repeated after 10 years – indicate a significant deterioration of the environment's state.**
- **Surveys performed in 2012 (after 13 years) indicate that the contaminated area may be even 2-3 times larger than it was previously considered to be contaminated with heavy fuels**
- **After initiating new technology - In 2014 – polluted area was determined as 10 times bigger than initially**
- **At 2015 we get proof – it is not end - polluted area is not less than 15 times bigger than initially**

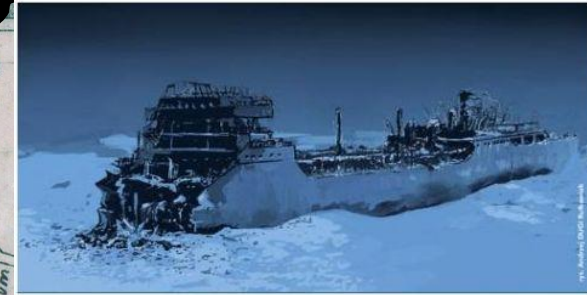
T/S FRANKEN - could still have about **6 thousand tons of fuel in its tanks**

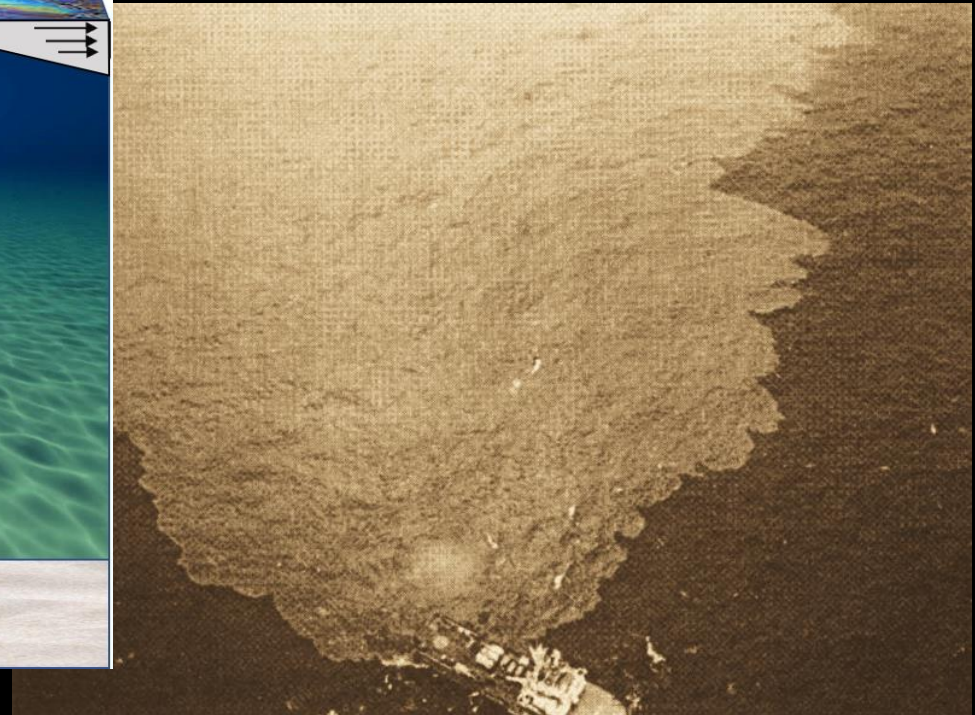
Standard distribution of oil leaking from wreck
